# Aviation Investigation Preliminary Report

<b>Location:</b>	New York, NY	<b>Accident Number:</b>	DCA26MA161
<b>Date &amp; Time:</b>	March 22, 2026, 23:37 Local	<b>Registration:</b>	C-GNJZ
<b>Aircraft:</b>	Mitsubishi CL-600	<b>Injuries:</b>	2 Fatal, 6 Serious, 33 Minor
<b>Flight Conducted Under:</b>	Part 129: Foreign

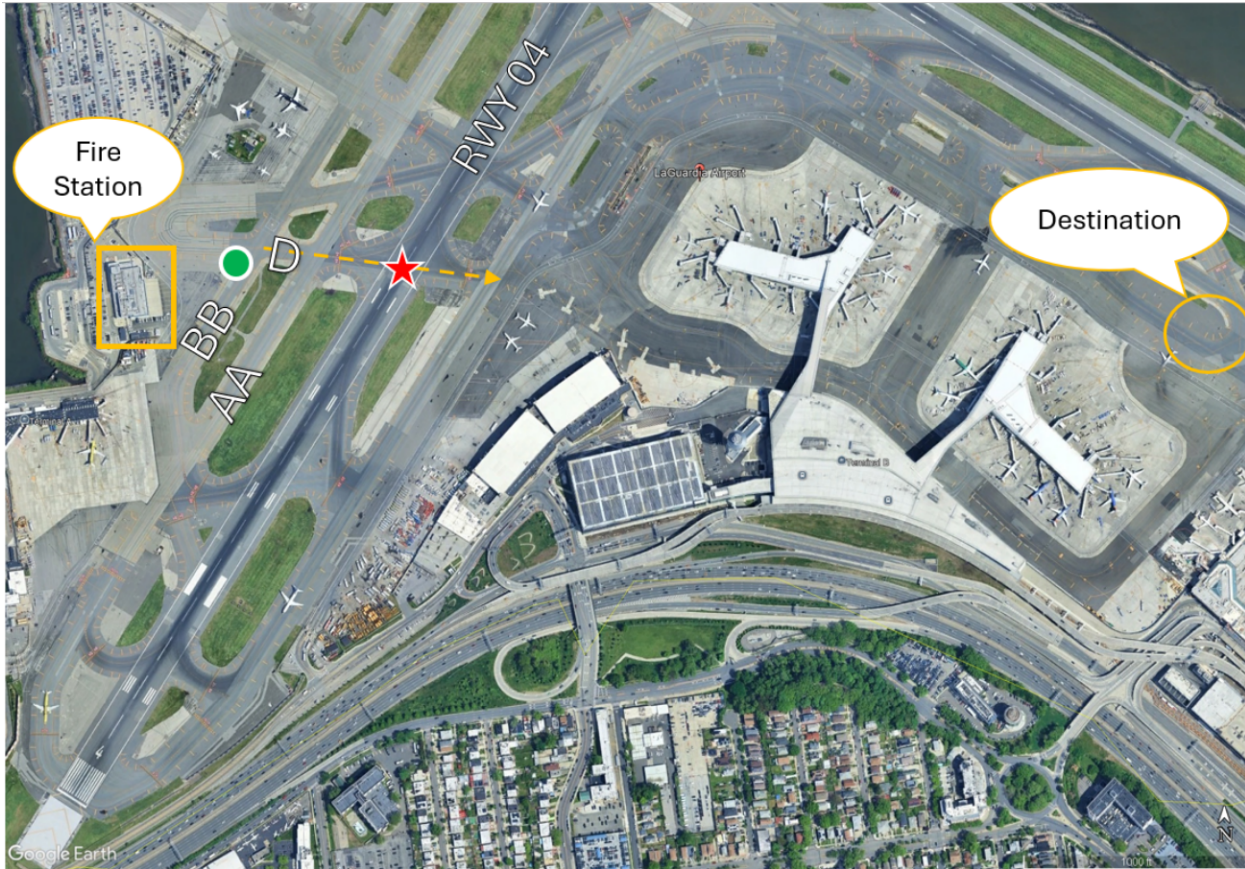
**Figure 1.** Google Earth image of the accident area, with the green circle indicating where the ground vehicles initially gathered, the yellow dash line their intended path on taxiway D, and the red star indicates where the collision occurred.

Truck 1 turned toward the left just prior to the collision. The airplane's rudder deflected about 6° to the left just prior to the end of the flight recorder data. The collision occurred at the intersection of taxiway D and runway 4 denoted by the red star in figure 1. The airplane's last recorded ground speed before the collision was 90 knots (104 mph).

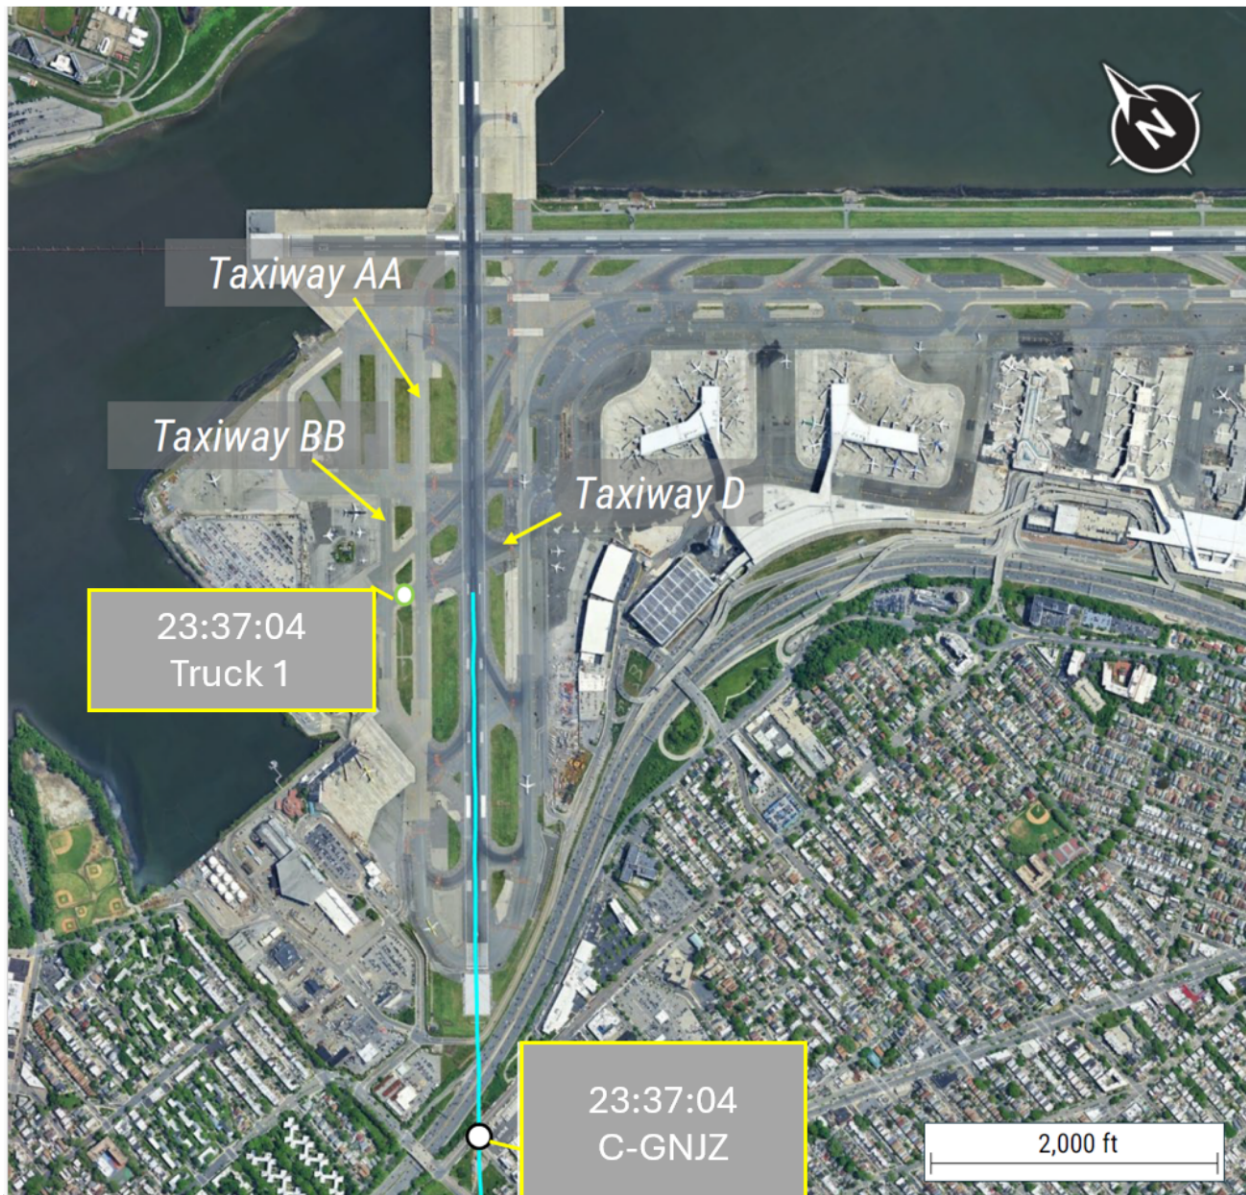
At 2336:56, Truck 1's crew replied to ATC with "Truck 1 and company", and the LC acknowledged. Truck 1 then requested "Truck 1 and company" to cross runway 4 at taxiway D, and the LC instructed them to cross. At that time, 2337:04, the airplane was at an altitude of about 130 ft above ground and about ¼ mile on final approach, which was about 4,400 ft away from taxiway D (see figure 2).

**Figure 2.** R35 (Truck 1) and Jazz flight 646 (C-GNJZ) positions at 23:37:04.

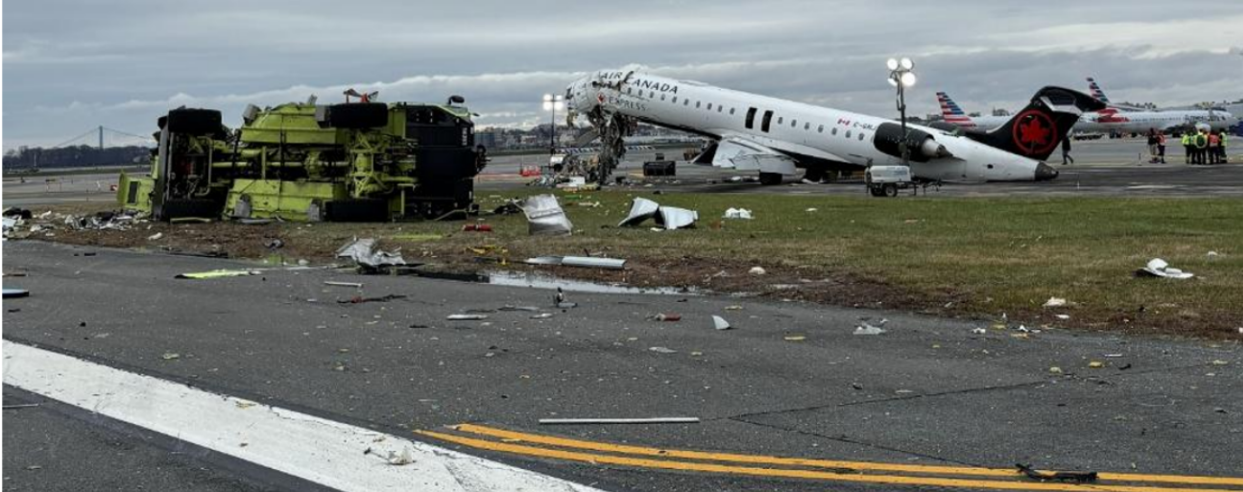
The airplane came to rest adjacent to taxiway B between taxiways D and E, upright on a heading of about 28° magnetic. Initially it was in a nose down attitude, due to the crush damage and partial separation of the forward fuselage and nose landing gear. Truck 1 came to rest just northwest of the airplane, on its left side, on a heading of about 206° magnetic.

**Figure 3.** View of both vehicles after collision.

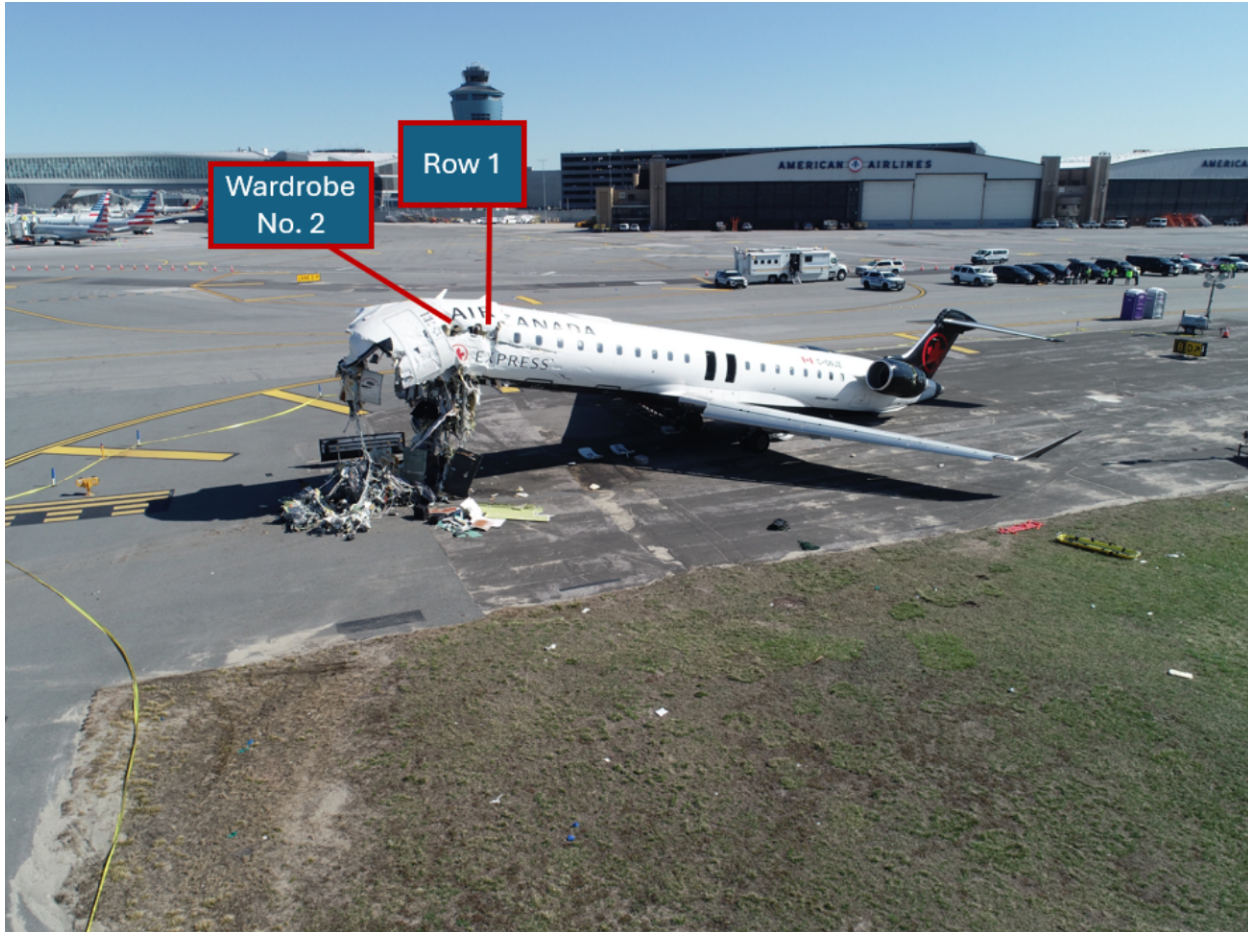
An examination of the airplane revealed that the most severe damage was forward of passenger seat row No. 1. Crush damage extended from the nose, to about the wardrobe No. 2 (coat closet) on the left side of the cabin and to about the forward lavatory on the right side. The two pilot seats, an unoccupied flight deck observer seat, and the forward flight attendant seat were separated from the airplane and found in the debris to the northeast (near the aft end) of Truck 1. All passenger seats were intact and remained secured to their attachment points. Seats 1A and 2A had inboard sidewall and seat leg deformation. The remainder of the passenger seats sustained minor or no damage.

There were no anomalies found with the pitch, roll, or yaw flight control surfaces. The leading edge slats and trailing edge flaps were found in their fully extended positions. All eight spoilers were found in the retracted position, however a review of the flight recorder data indicated that the ground spoilers activated about six seconds before the end of recorded data. Both thrust reversers were found in their fully deployed positions.

**Figure 4.** A view of the accident airplane from the left side.

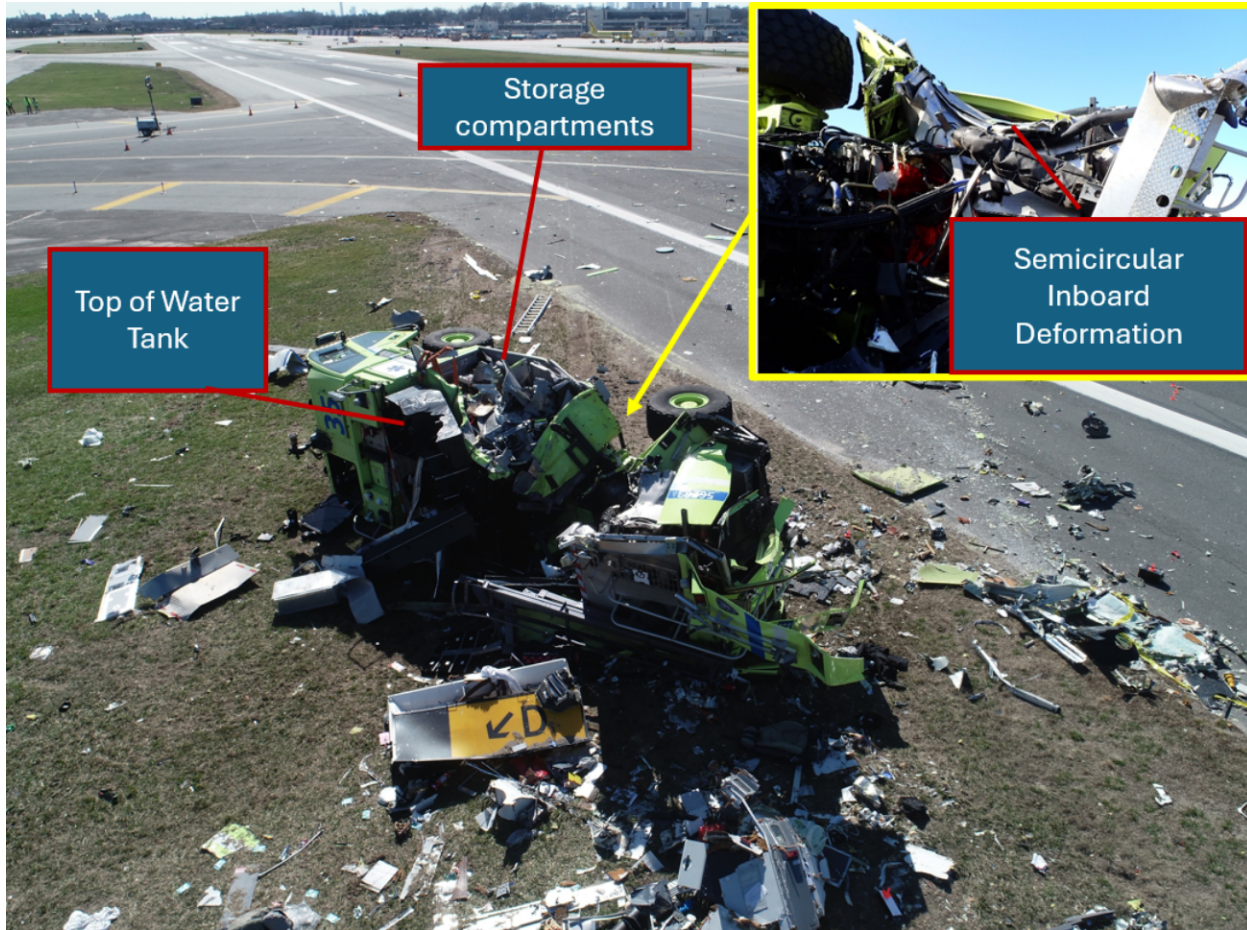
Examination of the R35 ARFF truck revealed it sustained substantial damage to its right-side body structure and equipment storage compartments. The 1,500-gallon water tank was fragmented, and all of the water was released. The 210-gallon foam tank was largely intact, though breached, and all of the foam was released. The right-side body structure had a semicircular indentation in the inboard direction, just forward of the right rear wheel. The operator cab was largely undamaged.

**Figure 5.** Truck 1 with a view of the right and top side of the truck.

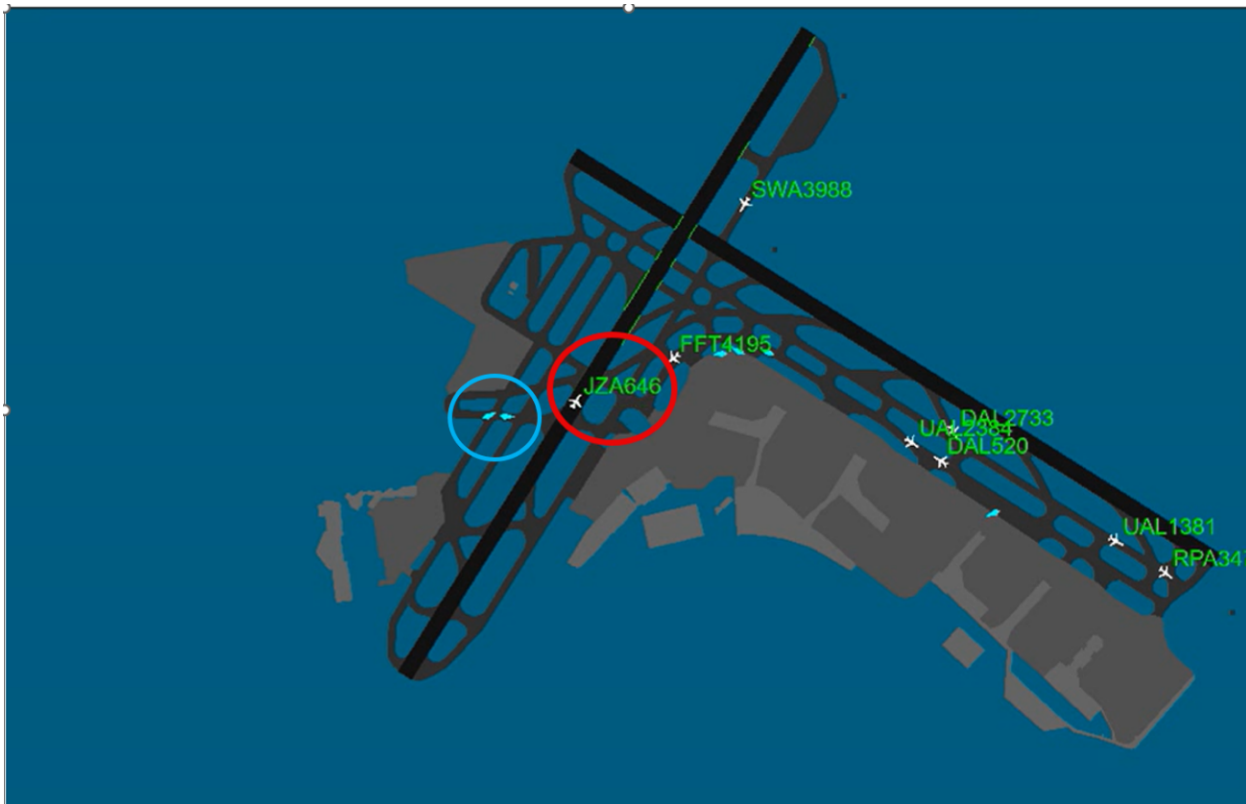
Multiple ground vehicles, none of which were equipped with transponders, were intermittently detected as radar targets, while holding on taxiway D at taxiway BB. However, due to their close (and varying) proximity to each other, and the intermittent merging and unmerging of radar targets, the ASDE-X system was unable to establish high-confidence tracks. At the time of the accident, ASDE-X displayed only two radar targets on taxiway D (near taxiway BB), rather than all seven of the response vehicles as distinct targets at their respective locations, see figure 7.

Without transponder-equipped vehicles, the ASDE-X system could not uniquely identify each of the seven responding vehicles or reliably determine their positions, or tracks. As a result, the system was unable to correlate the track of the airplane with the track of Truck 1 (or any of the other vehicles in the group) and did not predict a potential conflict with the landing airplane.

**Figure 7.** ADSE-X display just after the accident airplane passed taxiway D. JZA646 is the accident airplane and is shown within the red circle. The ground vehicles targets are shown in the cyan circle. (Source: FAA)

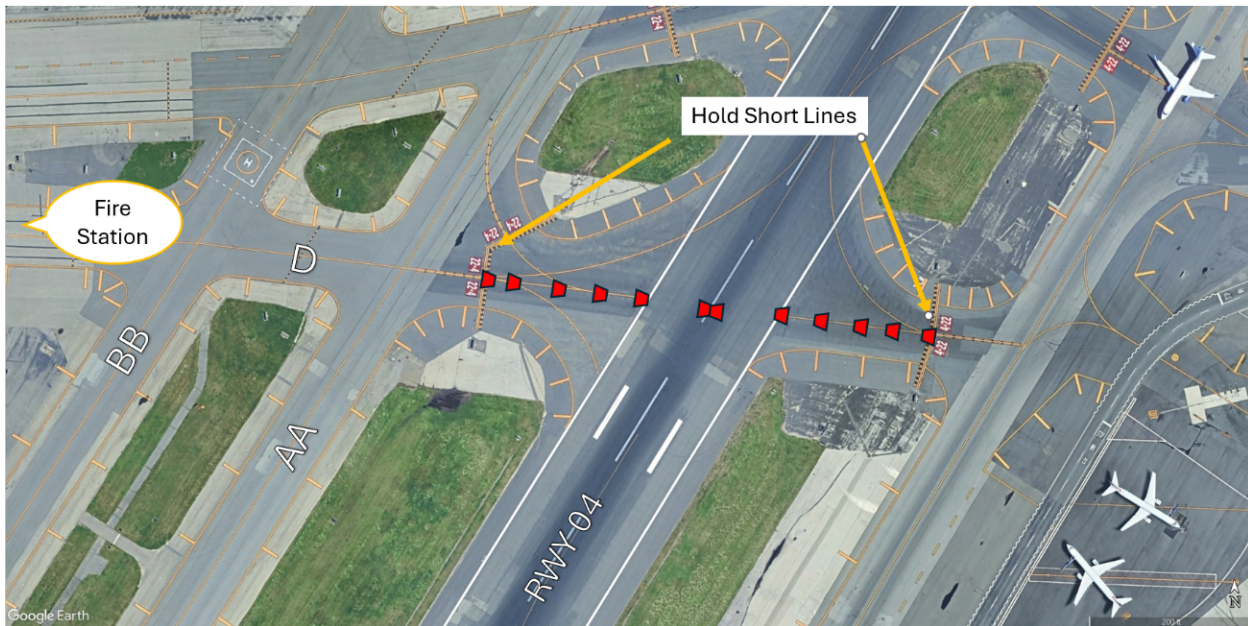
**Figure 8.** Depiction of runway entrance lights (RELs) for the intersection of taxiway D and runway 4.

These red lights are off when no runway traffic is approaching an intersection. They are automatically activated by the ASDE-X system when an airplane is approaching a runway for landing, or on a runway preparing to take off. As a landing airplane approaches the runway, the RELs at each of the equipped intersecting taxiways along the runway are simultaneously illuminated, to warn potential crossing traffic about the landing airplane. After an airplane touches down, the RELs turn off at each taxiway sequentially, as the airplane progresses down the runway. The system is designed to turn the lights off about 2 to 3 seconds before the airplane reaches each intersection.

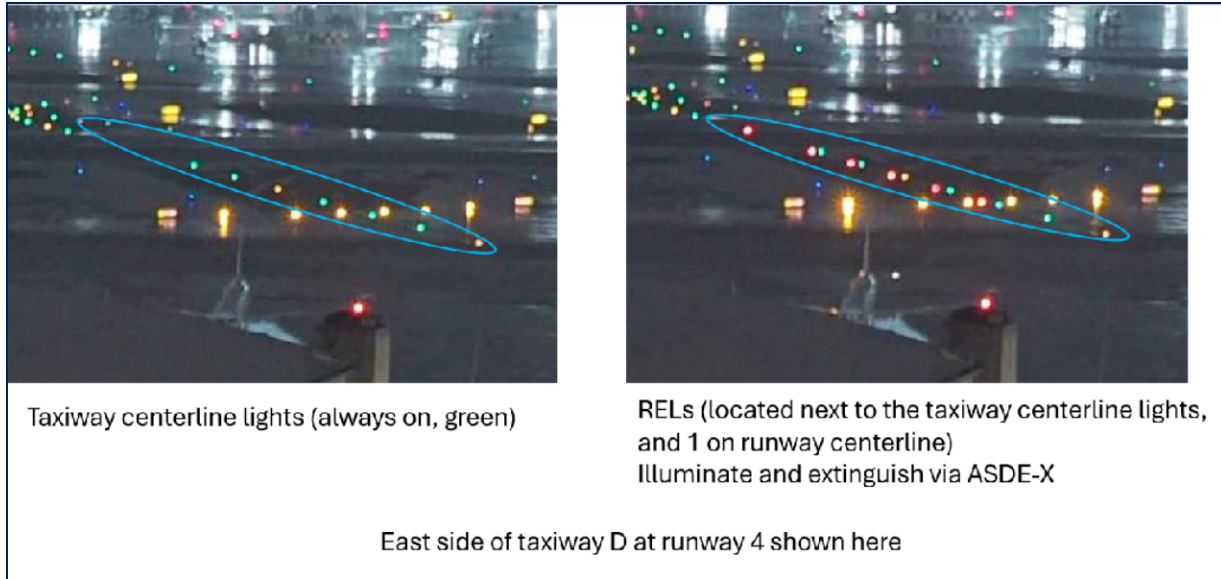
A review of airport surveillance video recordings revealed that the RELs illuminated for the arrival of the accident airplane, as Truck 1 and company were stationary in the vicinity of the taxiway AA and taxiway D intersection, about 300 ft away from the runway 4 hold short line on taxiway D. The RELs on taxiway D remained illuminated until about the time Truck 1 reached the (near) edge of runway, when they extinguished, about 3 seconds prior to the collision. Figure 9 shows surveillance video of the RELs both when off and when activated, on taxiway D east of runway 4.

**Figure 9.** Left image RELs OFF - Right image RELs ON. (Source: Port Authority of New York and New Jersey)
